# Service Bulletin

Bulletin No.: 20-NA-197

**Subject:** Malfunction Indicator Lamp (MIL) Illuminated - DTC P0087, P0089, P0191, P026C, P026D, P1089, P163A, P163B, P2293, P228A, P228B, P228C, and/or P228D

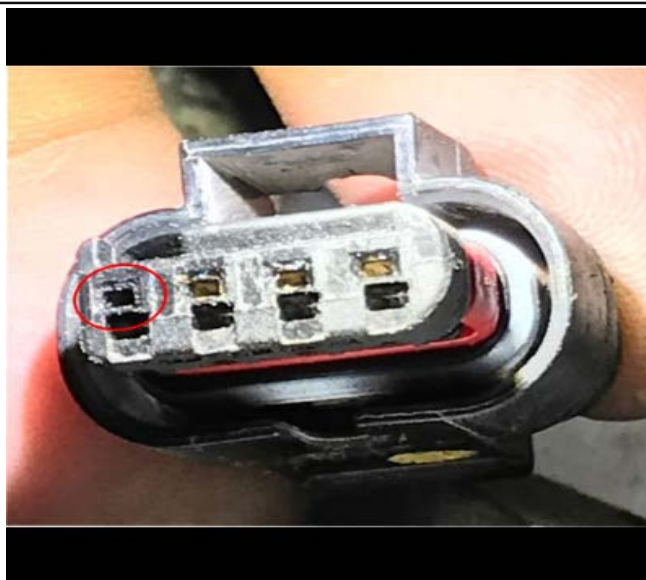
5652222

| Involved Region or Country | North America, Middle East, Israel, Palestine |
|---|---|
| Cause | This condition may be caused by corrosion or damaged at the fuel pressure sensor electrical connector. |

Inspect the fuel pressure sensor electrical connector for corrosion or damage.

⇒ It may be necessary to use the terminal test kit with dielectric grease on it and apply/drag each terminal a few times.
