Service Bulletin

Bulletin No.: 24-NA-103

Subject: Water Found in Rear Interior of Cab, Water Leak at Rear Sliding Window

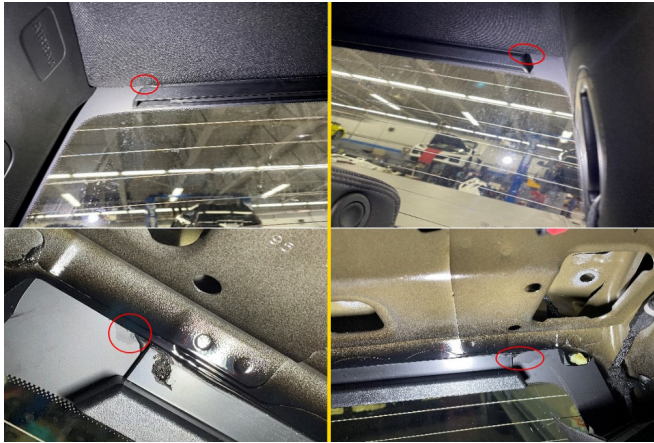
<p style="text-align: right;">6666033</p> <p>This condition may be caused by the pinholes in the urethane glass adhesive. Typically, at the ends of the plastic encapsulate for the rear glass.</p>
<p>Correction</p>	<p>Note: Do Not replace the rear glass for this concern. R & R the roof rear spoiler and apply seam sealer to the rear sliding window top encapsulate, following the steps in the Service Procedure below.</p>
