2006 Chevrolet EQUINOX

Subject: LNJ Service Engine Soon (SES) Light On, Multiple Powertrain Control Module (PCM) Diagnostic Trouble Code (DTC) P1404 and/or P0404 (Install EGR Valve/Gasket/Pipe/Wiring Harness Connector, Reprogram PCM) #06-06-04-008B - (03/19/2007)

Models: 2005-2006 Chevrolet Equinox

with 3.4L V6 Engine (VIN F -- RPO LNJ)

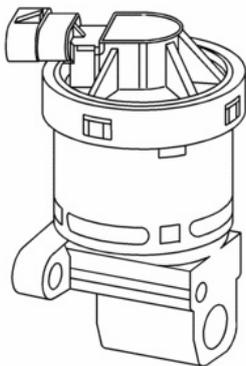
Siemens EGR Valve

Siemens EGR valves have a horizontal electrical connector.

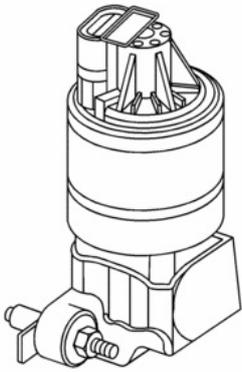
Delphi EGR Valve

Delphi EGR valves have a vertical electrical connector.

If a *Siemens* valve is *already* installed, it is *NOT* necessary to install this kit. Individual components are serviced.
