2014 Chevrolet Equinox

Subject: Wet Carpet/Floor at Driver and/or Passenger Footwell Areas

Models: 2010-2014 Chevrolet Equinox
2010-2014 GMC Terrain

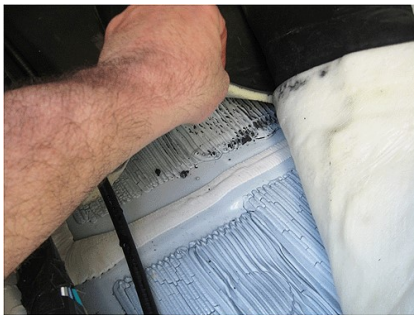
This condition may occur due to incomplete or insufficient sealing within the front roof to body side outer panel seams. The condition is most commonly found in the roof ditch within the first 30.5 cm (12 in) rearward from the windshield glass.

Inspect the vehicle for accumulated water or water spotting in the driver and passenger front footwell areas. Reposition the front carpet and inspect for water/spotting between the carpet and the floorboard.

If evidence of water is found in these locations, inspect the affected side roof ditch for possible voids in the sealer. Inspect for, and correct this leak, following the repair steps below:

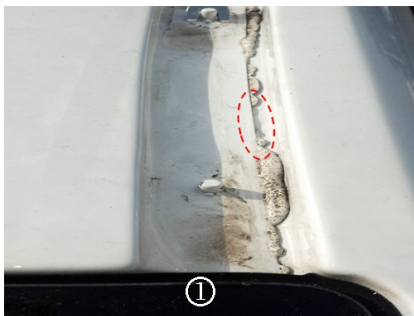
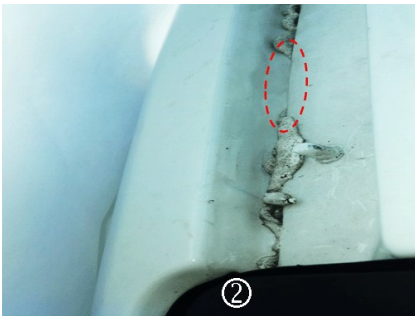
2. Inspect for voids/gaps in the seam sealer along the outboard edge of the roof ditch. Examples of this condition are shown in the driver side (1) and passenger side (2) graphics above.
3. Clean the affected area and seal all gaps with *Kent Automotive High-Tech™ Clear Seam Sealer, P/N 10200 (5 oz tube), or equivalent. Avoid excess sealer build up within the ditch while assuring any voids in the factory seal are filled.
4. Allow the seam sealer to adequately set-up, then water test by placing a water hose mid-roof near the ditch, allowing water to run forward to the A-pillar. Visually inspect for any water leaks along the inner roof, A-pillar and floor areas.
5. Once the repair is verified, reinstall the roof ditch molding. Refer to Roof Panel Molding Replacement in SI.
6. Dry the interior of the vehicle as needed. Refer to Floor Carpet Drying in SI.
