## #PIT3803: Water Leak from the Right Side of the Instrument Panel During Heavy Rain or When Going Through a Car Wash - keywords carpet case drain floor HVAC leak plenum wet - (Dec 15, 2005)

**Models:** 2006 Chevrolet Equinox  
Between VIN break points 66027135 to 66035604  
2006 Pontiac Torrent  
Between VIN break points 66030403 to 66040620

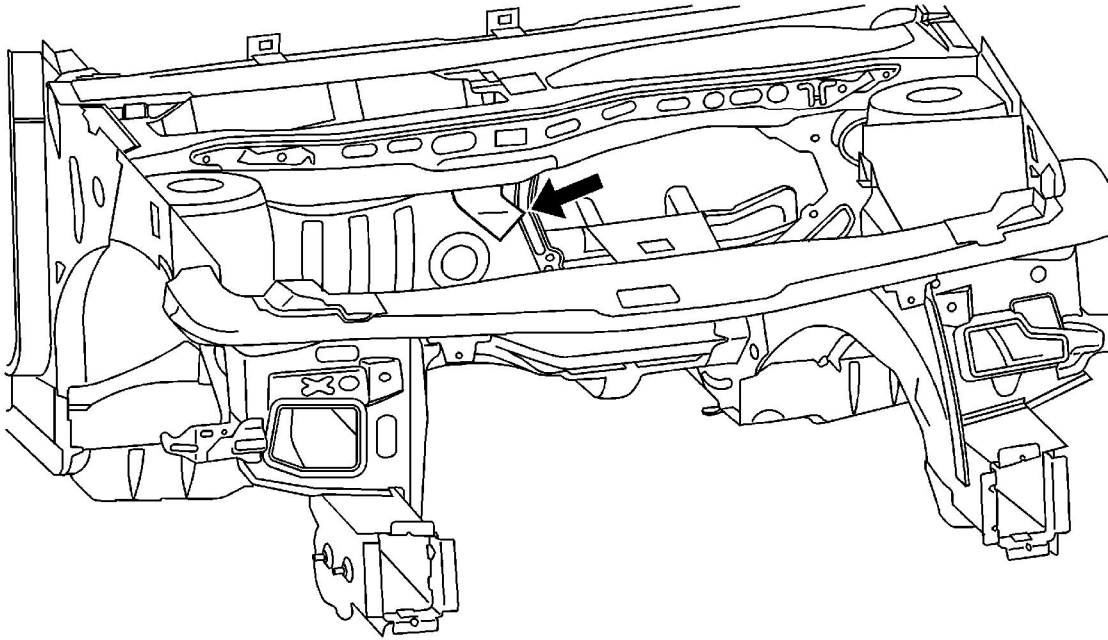
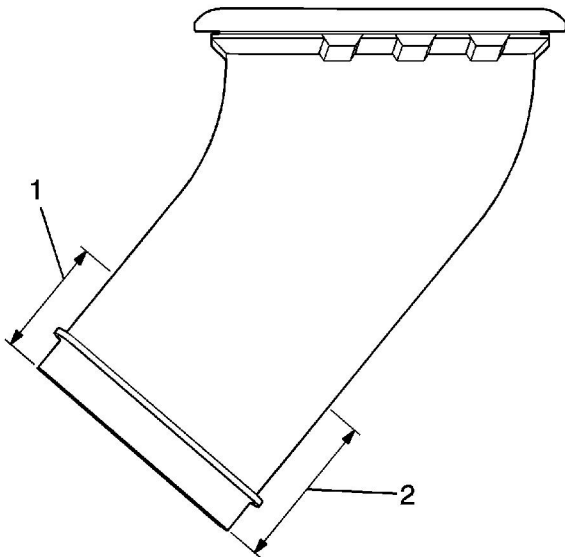
Some customers may comment of a water leak from the right side of the instrument panel when going through a car wash or during a heavy rain. The plenum drain plug was manufactured from an incorrect material that does not expand enough to allow water in the cowl to drain quickly enough.

Technicians are to cut two slits in the sides of the plenum drain plug. Refer to the attached illustration for the location of the plenum drain plug and for the dimensions of the cuts.
