2010 Chevrolet Equinox

Subject: Radio Touch Screen Unresponsive — Radio Control Assembly Contacting Radio Touch Screen (Remove Radio Control Assembly, Apply Loop Tape for Clearance)

Models: 2010 Chevrolet Equinox
2010 GMC Terrain
Equipped With Radio RPO UYS or UYX

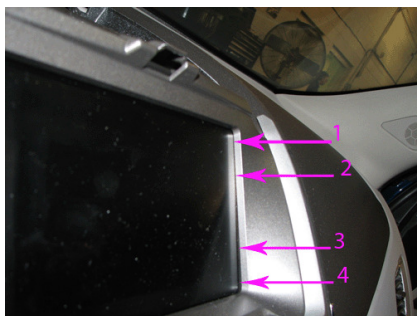
The cause of this concern may be the radio control assembly contacting the radio touch screen due to insufficient clearance. This results in the radio touch screen sensors falsely determining this contact to be a touch command.

1. Visually inspect the complete area around the rectangular radio touch screen for insufficient clearance as shown (1), (2). Compare to the area with sufficient clearance (3), (4) in order to make a determination of where to apply the loop tape.
