2005 Chevrolet Equinox

Subject: Reduced Power, Stuck in High Gear, SES Light On, DTCs P0223, P0504, P0700, P1228, P1271, P1280, P1599, P1779, P1791, P2119, P2101, P2128, P2135, or P2138 Set, Speaker Buzz Noise, HVAC Inoperative (Inspect/Replace Corroded or Bent Terminals)

Models: 2005–2006 Chevrolet Equinox
 2006 Pontiac Torrent
 2002–2003 Saturn VUE

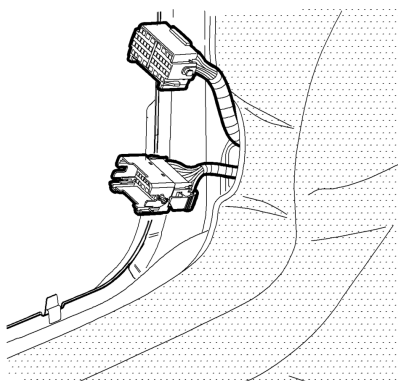
The instrument panel/body inline connector (black 40-pin electrical connector), located behind the *left* hinge pillar garnish molding, may have bent or corroded terminals.

3. Disconnect the instrument panel/body inline connector (black 40-pin electrical connector).

4. Inspect the connector for bent or corroded terminals.
- Important:** If no corrosion or bent terminals are found, proceed to Step 7 and follow trouble code diagnostics in the service manual or SI.
5. Remove any bent or corroded pins from the connector.
 6. Install the new terminal cut lead (verify correct size using connector/harness face views and electrical schematics in the appropriate service manual or SI).
 7. Pack the connector terminals with dielectric grease in order to prevent any further corrosion.
 8. Connect the instrument panel/body inline connector (black 40-pin electrical connector).
 9. Install the molding.
