2012 Chevrolet Equinox

Subject: EBCM Wheel Speed Sensor Diagnostic Aid for ABS Message - Click Or Ratchet Noise - Service Traction Message - Service Stabilitrac Message - Service Steering Message

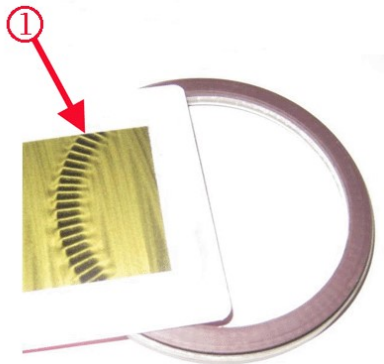
(1.) Wheel Speed Sensor

Magnetic Encoder Ring - North and South Poles are shown

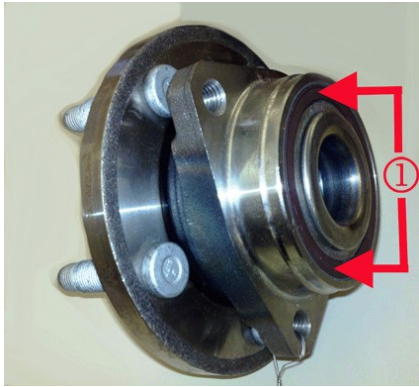
(1.) Magnetic Encoder Ring

Some new model vehicles today have begun to use a different type of wheel speed sensor encoder ring or tone wheel. Instead of a traditional mechanical type tooth tone wheel, the wheel speed sensor tone wheel is now made of a magnetized nitrile rubber ring, typically brown in color. This magnetic encoder consists of multiple North and South Pole pairs surrounding the outer circumference. When this magnetic encoder ring rotates and passes by the wheel speed sensor head, it generates a sign wave in the wheel speed sensor. The wheel speed sensor converts an analog signal to a digital square wave, and typical digital signal values switch between 7mA (Low) and 14mA (High) DC current.

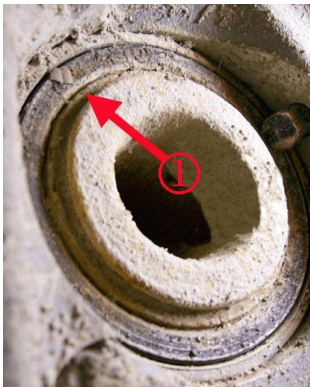
BEFORE CLEANING

These conditions may be caused by single or multiple pieces of ferrous metallic debris stuck to the wheel speed sensor magnetic encoder ring. This magnetic encoder ring is now part of the inboard bearing hub assembly.

(1.) Sample Debris

1. Gently using a dry nylon soft bristle brush, remove the foreign debris off the magnetic encoder ring. If debris was removed, proceed to step 3.
2. If debris still remains, wash the encoder ring using a mild soap detergent and wipe dry.
