**Bulletins > Body Repair > #21-NA-050: Paint Chipping or Peeling on Front Fascia, at Interface of Front Fender and Fascia Near Headlamp - (Jul 29, 2021)**

<b>Subject:</b>	Paint Chipping or Peeling on Front Fascia, at Interface of Front Fender and Fascia Near Headlamp
-----------------	--

Brand:	Model:	Model Year:		VIN:		Engine:	Transmission:
		from	to	from	to		
Cadillac	Escalade Models	2021	2021			All	All
Chevrolet	Suburban Tahoe						
GMC	Yukon Models

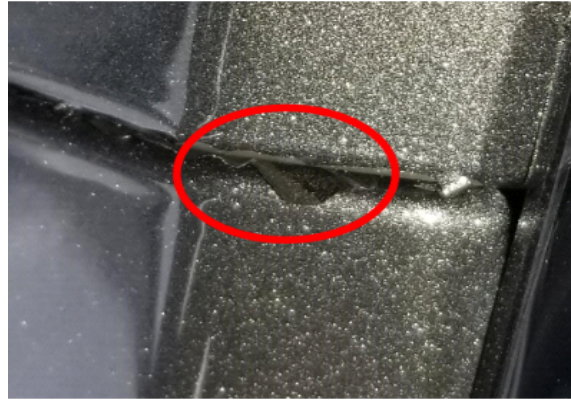
**Note:** Several examples of the paint damage is shown in the graphic above. The call-outs are (1) fender, (2) fascia and (3) headlamp.

Some customers may comment on seeing paint chipping or peeling on the front fascia at interface of front fender and fascia near headlamp.

The cause of the condition may be a fascia guide bracket stiffness issue.

Remove and reinstall the front fascia. and repair fascia paint as necessary.

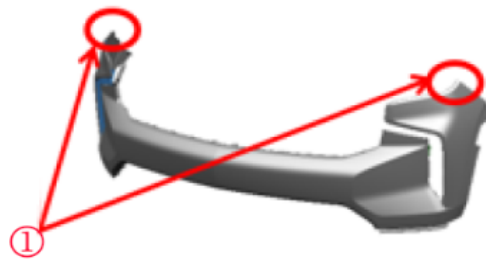
**Note:** The area(s) (1) of concern are commonly the rear, upper corners of either, or both sides, of the front fascia.

remove and reinstall the front fascia, and repair fascia paint as necessary, following the steps in the Service Procedure below.

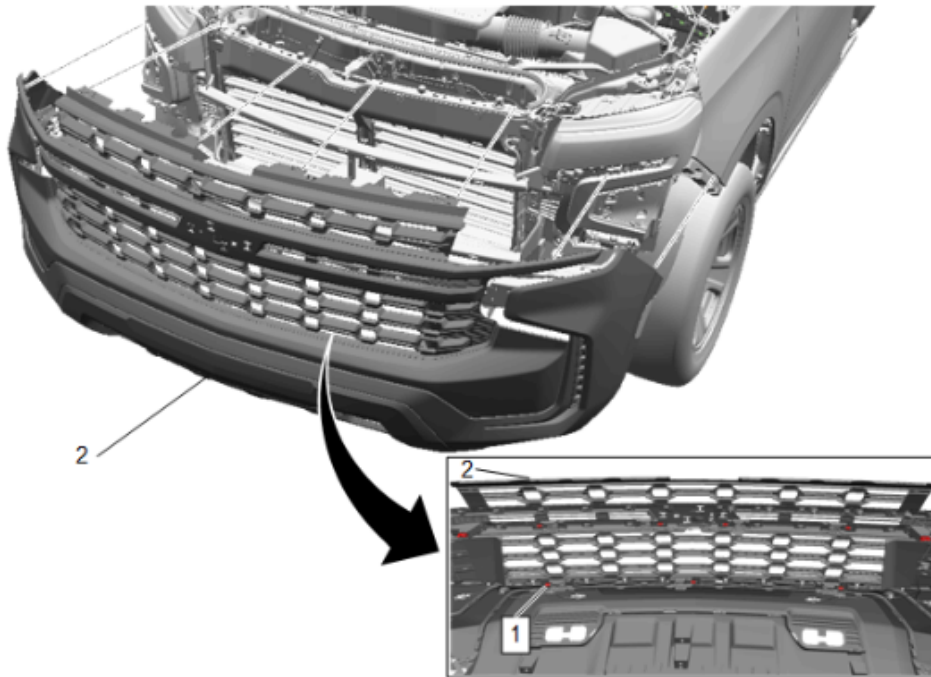
**Note:** A Chevrolet model is shown in the graphic above. Other models would be similar.

1. Remove the front fascia (2). Refer to the appropriate *Front Bumper Fascia Removal and Installation*, in SI.
