#PIT4846B: Locations Of High Speed GMLAN Wiring Concerns - keywords cycle gage gauge hard hi lamp LAN lock light MIL off shift short start - (Jan 27, 2010)

Subject: Locations Of High Speed GMLAN Wiring Concerns

Models: 2007-2010 Cadillac Escalade Models
2007-2010 Chevrolet Avalanche, Silverado, Suburban, Tahoe
2007-2010 GMC Sierra, Yukon, Yukon XL, Yukon Denali, Yukon Denali XL

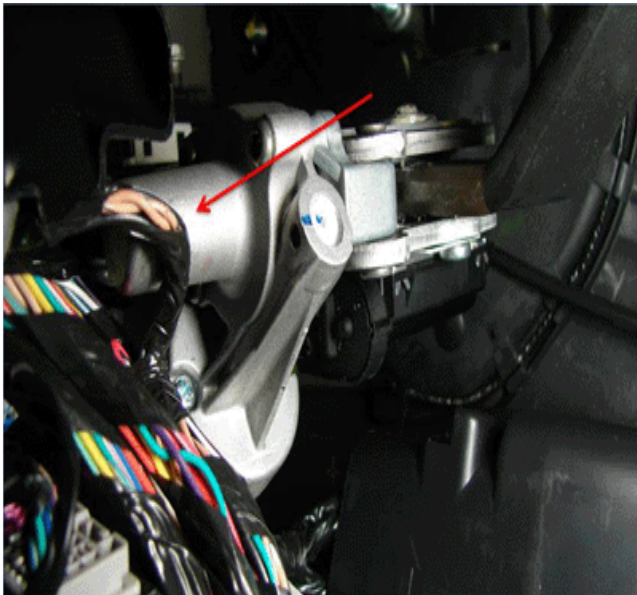
- Adjustable Pedal Motor- As the brake pedal is applied the DLC wiring harness may rub on the adjustable pedal motor and short out, shown below. One hint is the concern will normally occur when the brake pedal is being applied.

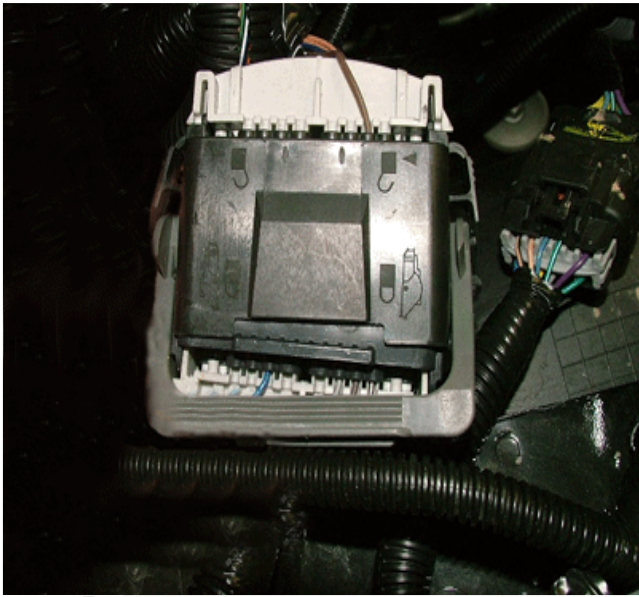
- Inline Connector X109-Inspect for backed out, bent, or poor terminal fit USING THE CORRECT TEST PROBE! Also check for the connector not being fully seated together even though the lever on the connector is locked down, shown below.

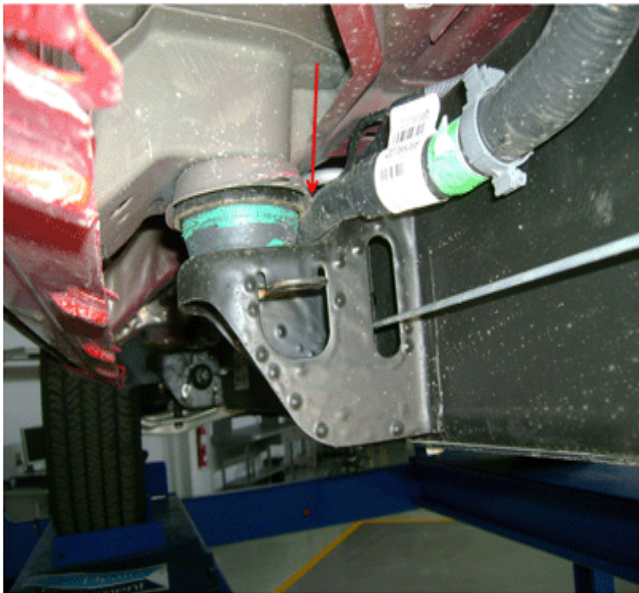
- 6L80/6I90 Auto Trans 16 way Round Pass Through Connector- Review bulletin 08-07-30-021B for more information.
- Chaffed Harness Near Parking Brake Pedal/Sill Plate Area- Refer to bulletin 07-08-49-018 for more information
- Chaffed Harness at the Left IP Junction Block Mounting Bracket- Remove junction block and inspect for any shorted/chaffed wiring.
- Pickup Chassis Harness Chaffing At the Body Mounts Along Left Frame Rail, see below.

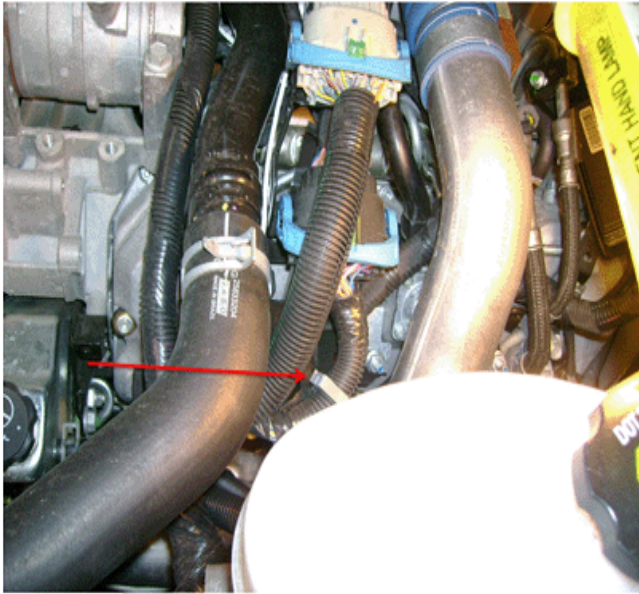
- Trucks with Diesel Engine inspect the engine wire harness for chaffing on the connector/harness mounting bracket at the X108 connector break out, shown below.
