Technical Bulletin

Section Title: Body
 TSB No. TS 02 08092

SUBJECT: FRONT DOOR WINDOW GLASS TIPS FORWARD WHEN CLOSING
MODEL(S): VITARA 2.0
YEAR: 1999-2002
AFFECTED VIN(S): ALL

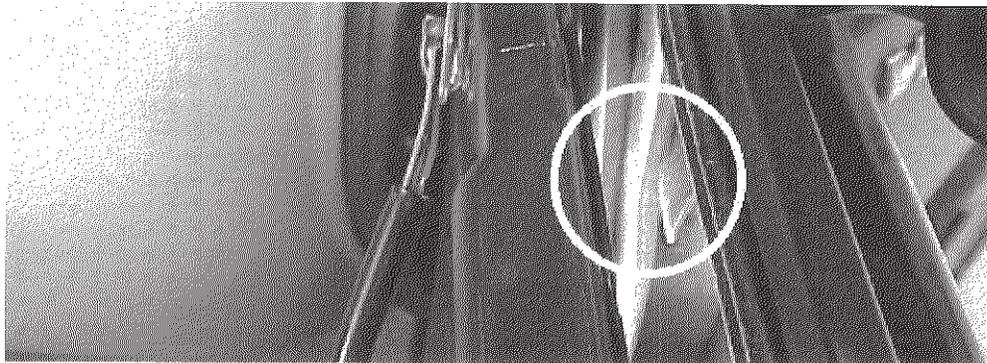
CAUSE: The weather-strip run channel bracket inside the door may be pinching the run channel weather-strip, binding the glass as it slides in the channel.

The below picture shows the area on the weather-strip run channel bracket that is pinching the glass run channel weatherstrip.

CORRECTION: Relieve the front door window glass run channel weather-strip(s) as shown in this bulletin.
