ProAir

Customer Service Manual

Release Date: 30 November 2000

ProAir has designed this manual to assist in diagnosing and servicing our rear heat/cool units. We have organized it by chassis-specific sections. Within each of these sections we have included ProAir requirements and factory connection points, concern categories (heating, cooling, electrical, and airflow), wiring schematics, system-diagnosis flowcharts, exploded-view diagrams, and parts lists. You will also find sections on replacement/repair procedures, technical information bulletins, and our warranty statement. Please refer to the table of contents for further details.

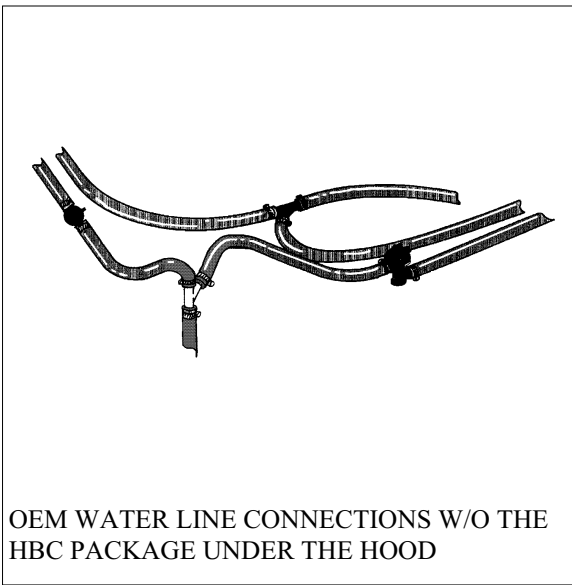
DODGE B-VAN FACTORY CONNECTION POINTS W/O HBC

For vehicles without the HBC package, the locations for A/C and heat connections are shown below.

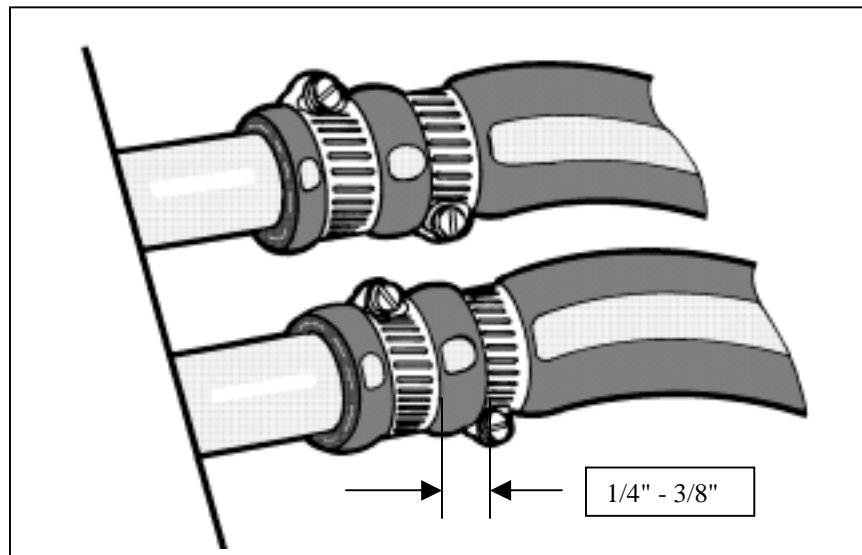
HOSE CLAMPS - GM VANS W/YF7 - WATER LINE CONNECTIONS

There is a slight tendency for coolant leakage at the joint where the auxiliary hoses attach to the OEM aluminum lines. To ensure a completely sealed connection, two worm gear clamps on each hose will be used. The positioning of the clamps and the tightening screw are critical. The tightening screws must be positioned 180° from each other and facing in the same direction, as shown in the illustration below. Tighten the worm gear screws to 30 in/lb of torque. The hoses from the rear auxiliary unit should be pushed onto the OEM aluminum lines a minimum of 2 1/2". To achieve maximum sealing, place the clamps 1/4" to 3/8" apart.
