#PIT5313C: Paint Peeling Above Anti-Chip Area - (May 8, 2015)

Models: 2014 Chevrolet Silverado 1500
2015 Chevrolet Silverado 2500/3500
2014 GMC Sierra 1500
2015 GMC Sierra 2500/3500
Built at Ft. Wayne Assembly (11th VIN Position = Z)
Built Prior to 5/15/2014

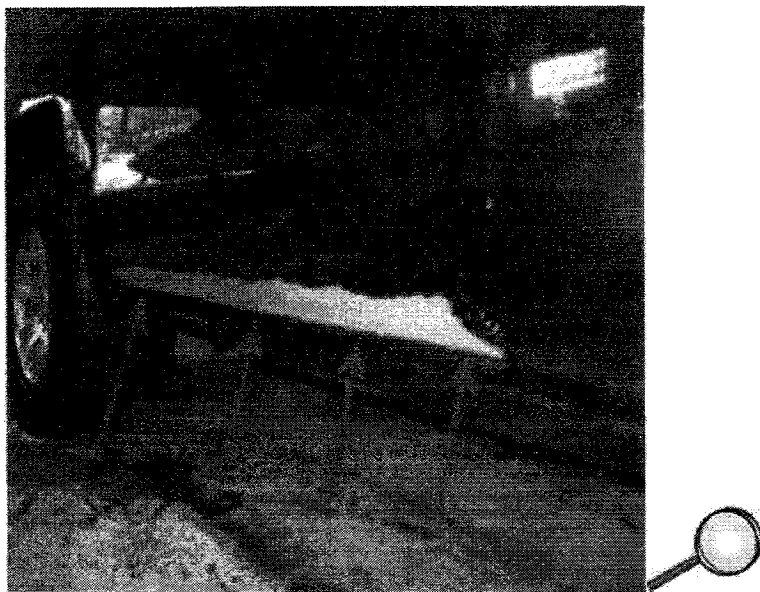
Some owners may comment of the paint peeling above the Anti-chip area, example shown below.

If a vehicle comes in for this concern, a test should be performed on the remaining panels using the following

This test should only be conducted on a vehicle exhibiting this condition and performed above the Anti-Chip area. On a clean surface, at or above room temperature, firmly apply a 2" wide piece of masking tape to the body, and pull upward quickly. Do not use duct tape, cloth backed tape, or other aggressive tapes. If the paint flakes or peels away, the panel in question should be repaired.
