2006 Chevrolet EQUINOX

Subject: LNJ Service Engine Soon (SES) Light On, Multiple Powertrain Control Module (PCM) Diagnostic Trouble Code (DTC) P1404 and/or P0404 (Install EGR Valve/Gasket/Pipe/Wiring Harness Connector, Reprogram PCM) #06-06-04-008B - (03/19/2007)

Models: 2005-2006 Chevrolet Equinox

with 3.4L V6 Engine (VIN F -- RPO LNJ)

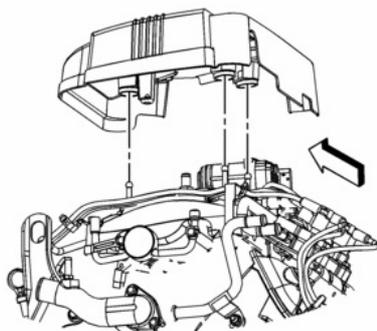
Failure to correctly wire the EGR valve electrical connector will result in a PCM diagnostic code to set and result in a "Service Engine Soon" indicator lamp to illuminate.

22. Connect the engine harness electrical connector to the EGR valve.
