**Bulletins > Body Repair > #21-NA-050: Paint Chipping or Peeling on Front Fascia, at Interface of Front Fender and Fascia Near Headlamp - (Jul 29, 2021)**

<b>Subject:</b>	Paint Chipping or Peeling on Front Fascia, at Interface of Front Fender and Fascia Near Headlamp
-----------------	--

Brand:	Model:	Model Year:		VIN:		Engine:	Transmission:
		from	to	from	to		
Cadillac	Escalade Models	2021	2021			All	All
Chevrolet	Suburban Tahoe						
GMC	Yukon Models

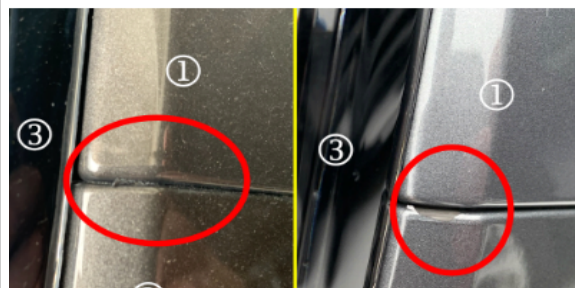
Some customers may comment on seeing paint chipping or peeling on the front fascia at interface of front fender and fascia near headlamp.

The cause of the condition may be a fascia guide bracket stiffness issue.

Remove and reinstall the front fascia. and repair fascia paint as necessary.
