Headlamp Replacement (Tahoe, Avalanche)

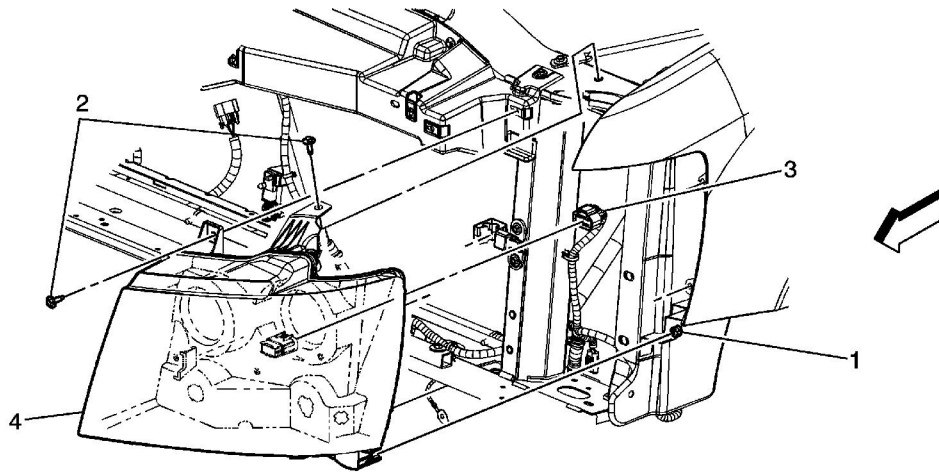
Callout	Component Name
<p>Preliminary Procedures</p> <ol style="list-style-type: none"> 1. Remove the 2 forward wheelhouse liner screws in order to access the hidden lower headlamp bolt. Refer to Front Wheelhouse Liner Replacement - Left Side or Front Wheelhouse Liner Replacement - Right Side . 2. Open the hood. 3. Remove the upper fascia bolts. 4. Remove the lower rear fascia bolt from the support bracket. 5. Loosen the 2 fascia to fender bolts from behind the wheelhouse liner. 6. Pull the outboard end of the front fascia straight outboard until it disengages from the fender attachment bracket. 7. Pull the fascia forward and downward to allow enough clearance to remove the headlamp assembly. 8. Remove the 2 upper headlamp bolts. 9. Grasp the headlamp at the upper inboard and lower outboard side and pull the headlamp forward to disengage the locating pins from the fender panel. 10. Pull the outboard side of the headlamp forward until the locating pin is disengaged from the radiator support. 11. Disconnect the electrical harness connector.

1	<p>Headlamp Bolt</p> <p>Caution: Refer to Fastener Caution in the Preface section.</p> <p>Tighten 6 N·m (53 lb in)</p>
2	<p>Headlamp Bolt</p> <p>Tighten</p>

6 N·m (53 lb in)
3	Forward Lamp Harness Electrical Connector
4	Headlamp Assembly Tip Upon re-assembly, align the locating tab along with the outer locating pins prior to applying inward pressure to the headlamp assembly.
