09-06-04-028D: [MIL](#) Illuminated, DTCs P0442, P0446, P0455 or P0449 Set - [Fuel Tank](#) Hard to Fill - Moisture, Water, Corrosion at [EVAP](#) CVS Valve - (Apr 22, 2014)

Models: 2007-2010 Cadillac Escalade Models

2007-2010 Chevrolet Avalanche, Suburban 1500, Tahoe

2007-2010 GMC Yukon Models, Yukon XL 1500 Models

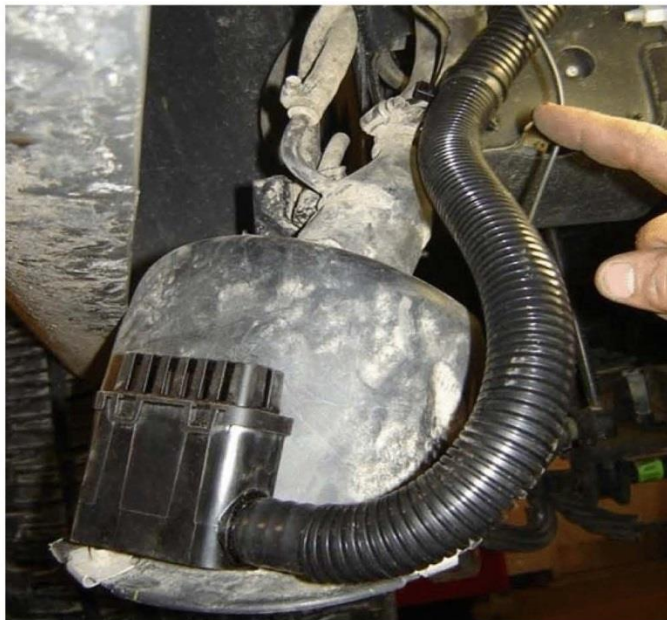
22. Position the CVS valve vent hose along the fuel fill pipe as shown.

22.1. Position the CVS valve pre-filter on the fuel tank filler pipe housing as shown. Align the hole in the CVS valve pre-filter with the hole that was drilled into the fuel tank filler pipe housing. Install the pushpin, P/N 10121502, from within the fuel tank filler pipe housing securely into the CVS valve pre-filter.

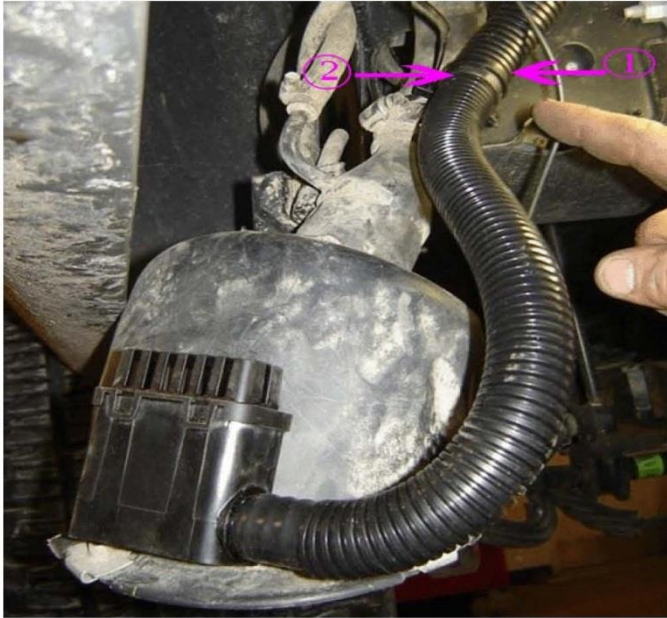
22.2. In the area near the [fuel tank](#) fill pipe to fuel tank fill hose clamp, secure the tie-strap (1) that was provided on the CVS valve vent hose to the fuel tank fill pipe as shown.

22.3. While holding the CVS valve vent hose and CVS valve pre-filter in position, install one additional tie-strap (2), P/N 11509087, around the CVS valve vent hose only, next to the provided tie-strap (1), on the fuel filler housing side of the strap. While maintaining the proper orientation of the CVS valve pre-filter, secure the additional tie-strap (2) in order to keep the CVS valve vent hose from slipping down, once the fuel filler housing has been raised back to its original position.

22.4. Secure the other tie-strap that was provided on the CVS valve vent hose to the fuel fill pipe.
